UTILISING IOT TECHNOLOGY TO
VALIDATE RETROFIT INTERVENTIONS

A CASE STUDY EXPLORING
HOW THE DATA FROM
HOMELINK ENVIRONMENTAL
SENSORS CAN BE USED TO
VALIDATE SUSTAINABILITY
INTERVENTIONS.

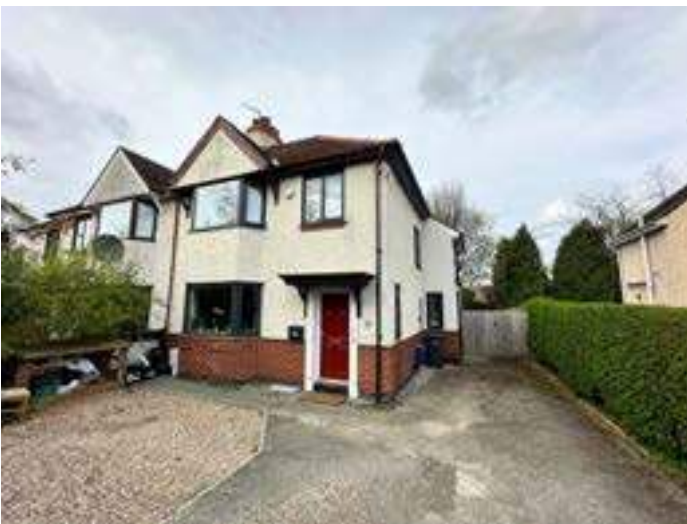
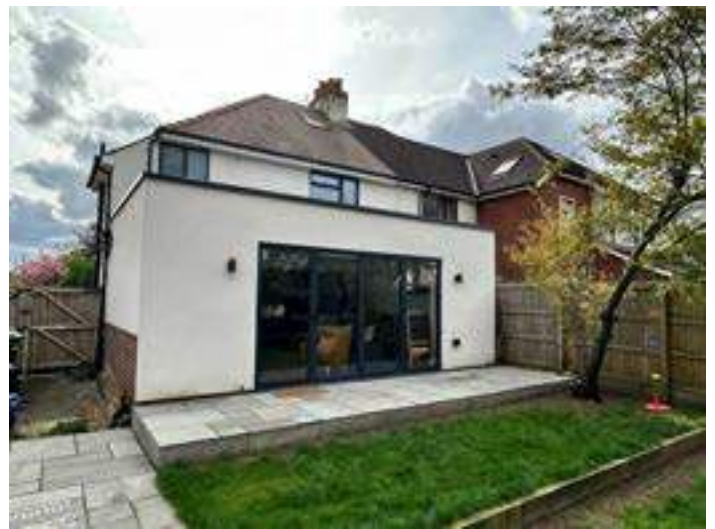
The property at the centre of this case study is a 1930's semi-detached house in York. Constructed with solid brick, the original render to the front and side of the property was inefficient, while the rear extension, covered in cracked and discoloured monocouche rendering, further contributed to heat loss.

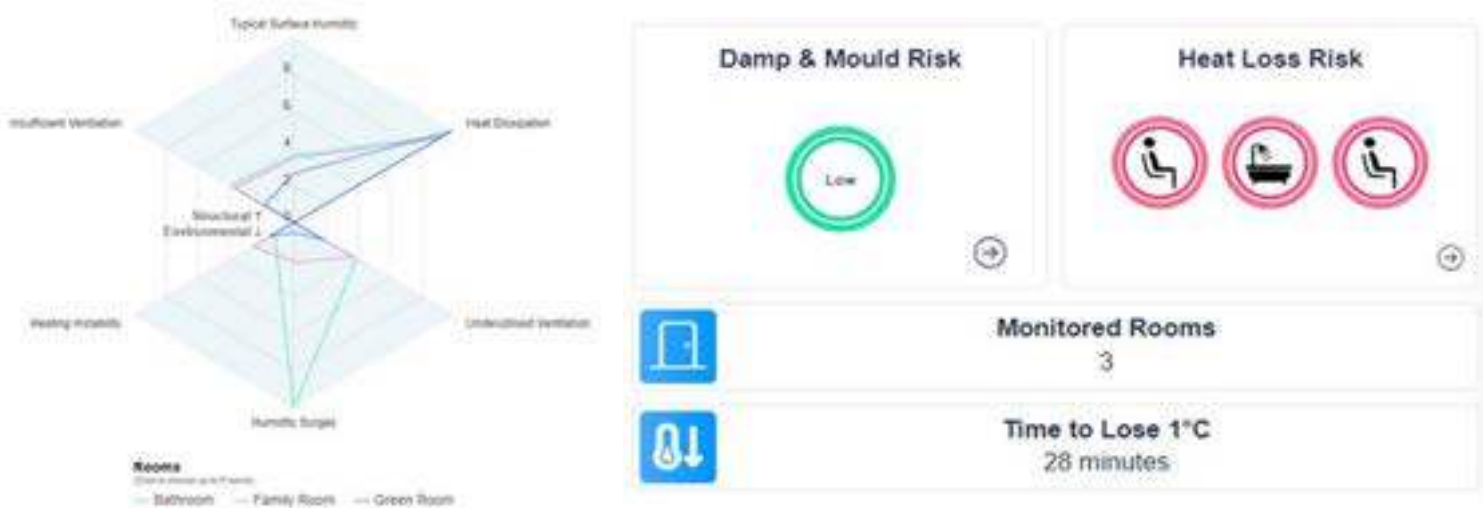
The data collected from the sensors echoed the EPC, identifying that the property had a high heat loss risk across the 3 rooms monitored: the bathroom, family room and green room. Additionally, the average Time to Lose 1 degree (TTL) of 28 minutes indicates a quicker rate of heat loss. The actionable insights show that heat dissipation is an issue across all monitored rooms and, when compared to humidity and ventilation, is the biggest problem in the home. This reflects the lack of insulation in the walls, confirming the assumptions in the EPC.

The TTL value can be used to provide a comparison of heat loss across different homes. It is calculated by utilising both internal and external temperature conditions, meaning we have the ability to understand how quickly a room is losing heat to the outside world. With machine learning models, the relative impact external temperatures have on internal temperatures - and the impact internal temperature have on each other - can be captured. This allows us to produce an accurate prediction of the temperature a room will be cooling down to.

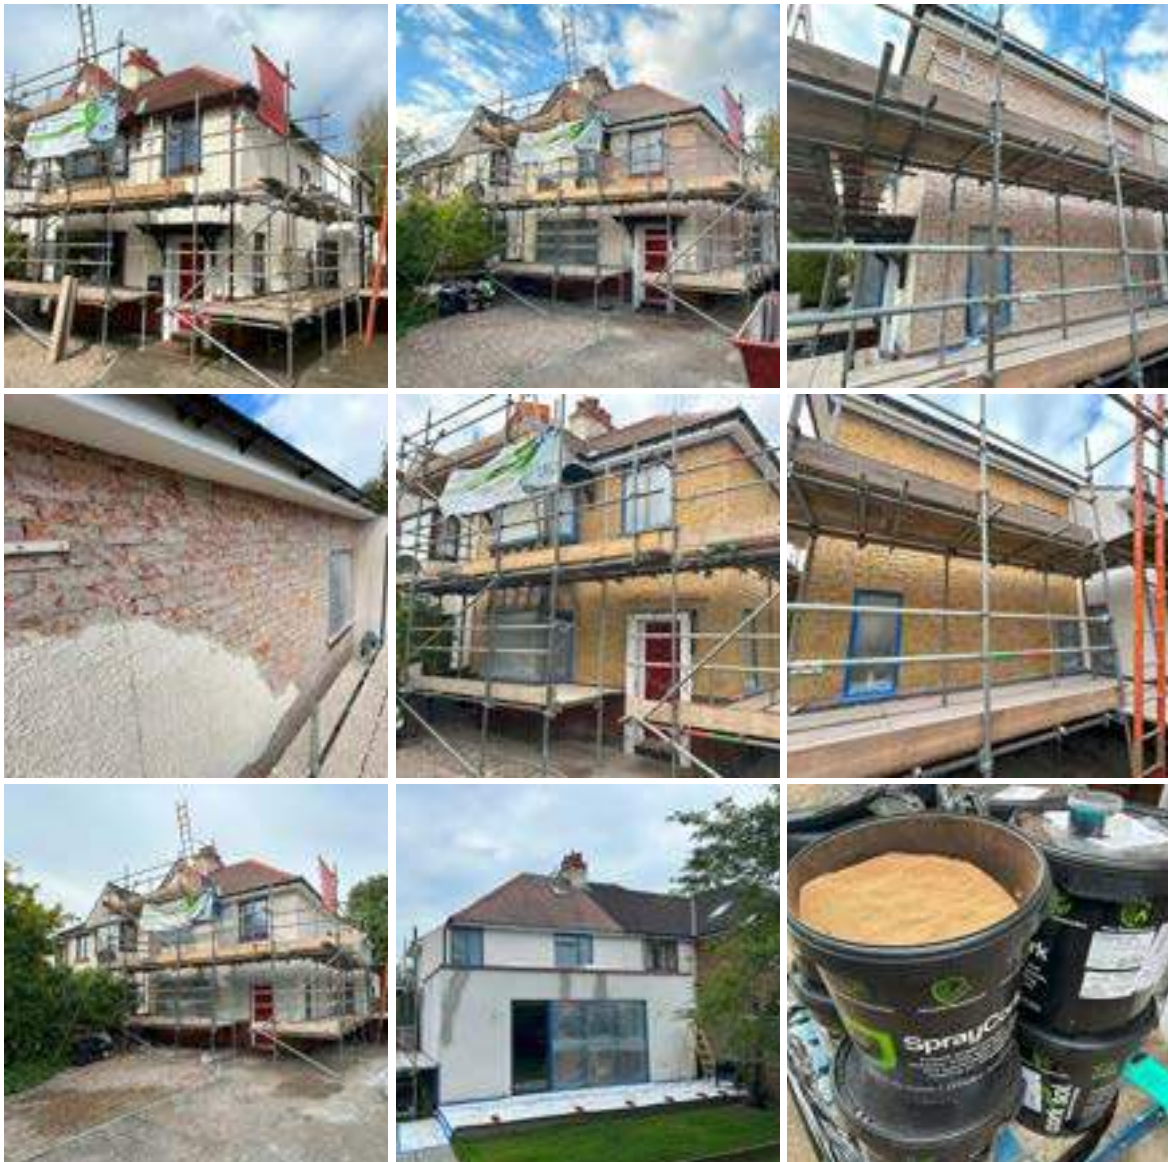
The installation was carried out by JMB Plastering Specialists, a well-established, CorkSol UK-approved applicator. The process involved removing all the existing render, investigating the area and tying any cracks in the brickwork. The brickwork was then sealed and primed before a new scratch coat was applied. There was no need to remove the existing monocouche as this could be sprayed straight over the top. All the windows, fascia and soffits were then taped up, ready to be sprayed.

The spraying was completed within a few days, and the home looked fantastic once complete. However, the crucial question was yet to be answered; could the claim of reducing heat loss by up to 30% be validated?

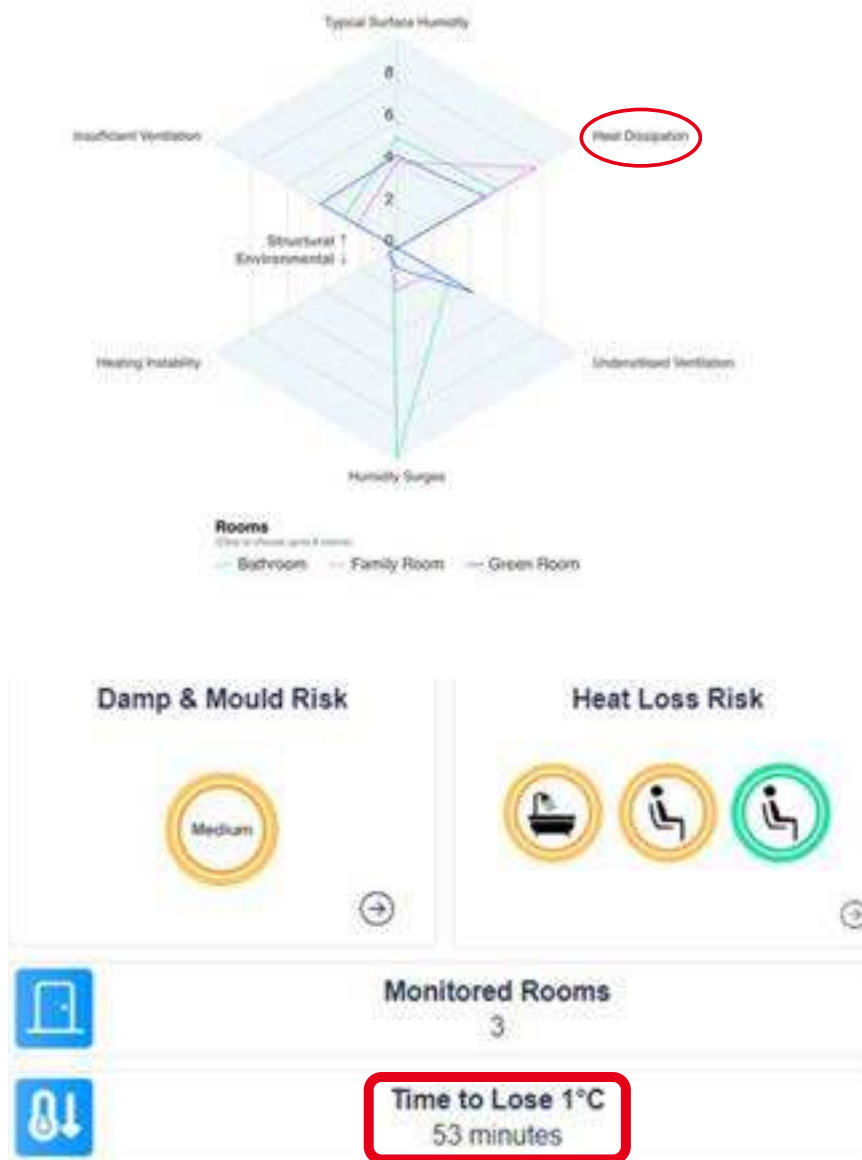
The results showed a significant improvement in the property's energy performance. Heat loss risk had changed from high across all three rooms to medium in 2 and low in 1. In line with this, the TTL 1 degree had increased from 28 minutes to 53 minutes, a huge increase of 25 minutes. This demonstrated a huge improvement in the energy efficiency of the home.

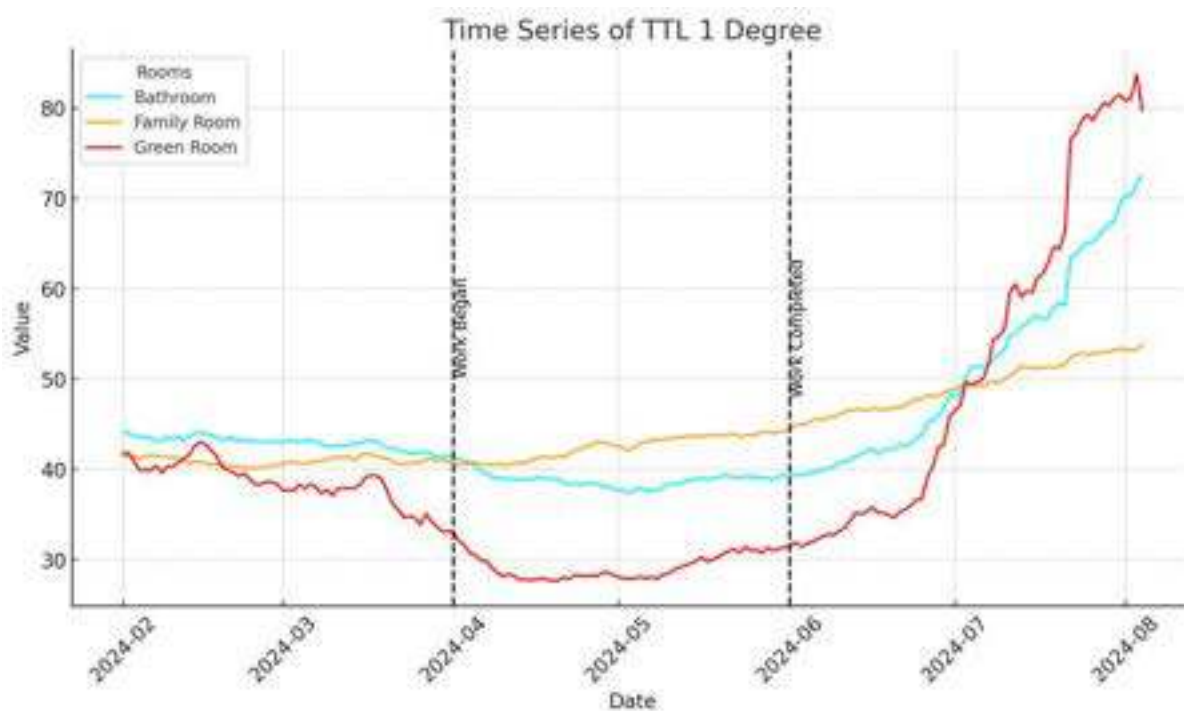
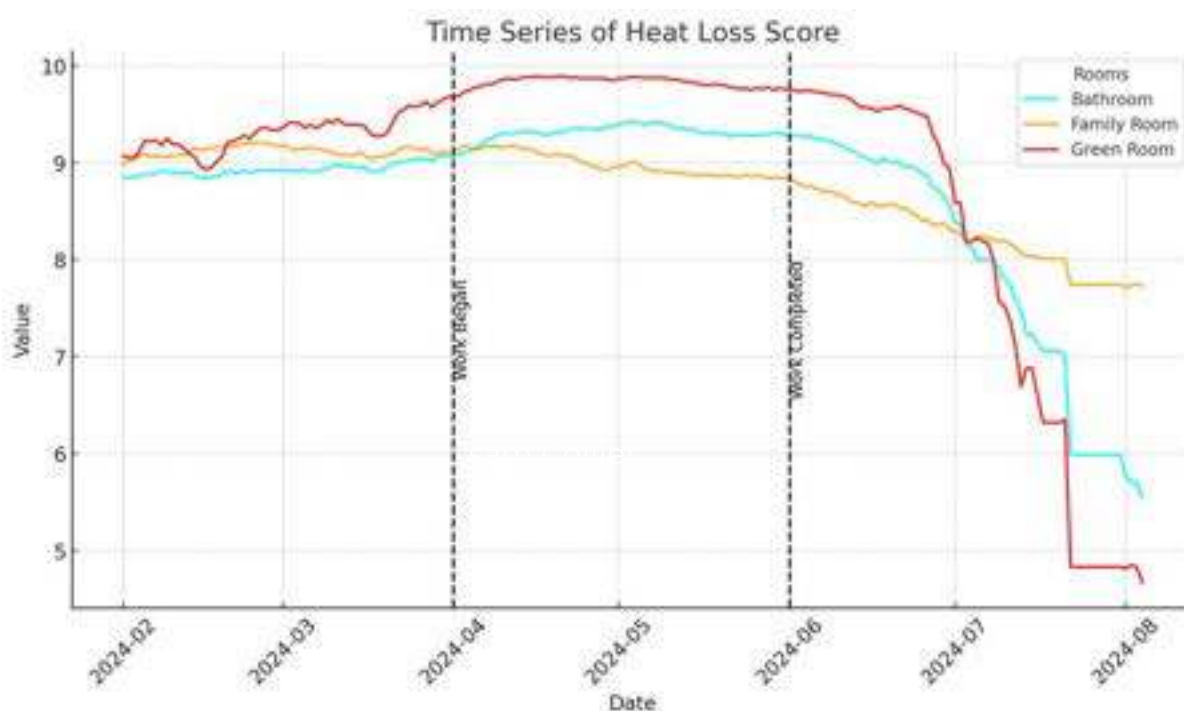
Comparing the changes to TTL and heat loss scores over time demonstrates the positive impact the intervention has had. In addition, heat dissipation improved across all rooms, with more than a 50% improvement in the 'Green Room.' This suggests that CorkSol has doubled the fabric's ability to retain heat within the building, with a notable impact in this room due to the presence of a poorly insulated bay window. Ongoing monitoring by the landlord will be essential to assess the long-term impact of the intervention.
